NPDES Permit Number: MAR10D585

Project Name: **Route 62 Roadway Resurfacing and Reconstruction**
Project Address: Route 62 Concord, Massachusetts
Project Proponent: **Town of Concord Public Works/ MHD**
Report Prepared By: Mary Trudeau, Environmental Consultant
Date of Report/Site Visit: October 9, 2009

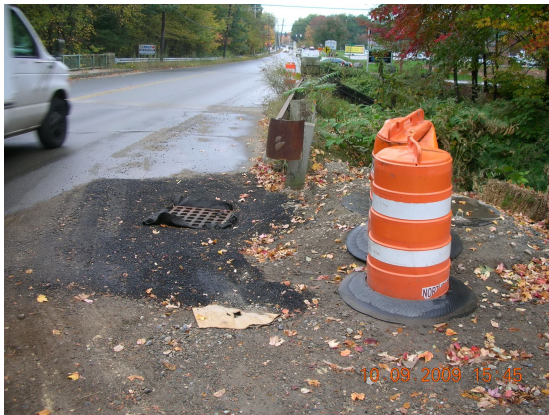
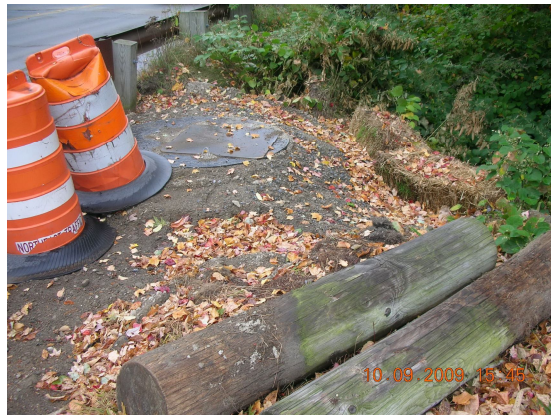
As noted in last weeks report, the contractor installed a new drainage structure at the junction of Route 62 and the Assabet River, at the Acton town line. The installation of this structure (on the northeast quadrant of the intersection) resulted in the disturbance of soils adjacent to the existing catchbasin in the locus. A liner was added to the structure prior to the rain event on October 3 and 4, 2009. The following photos show this work area:

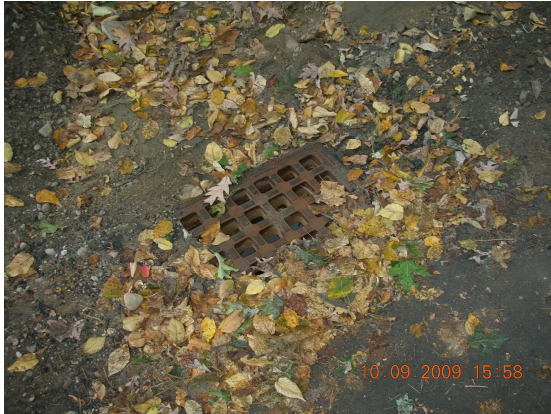
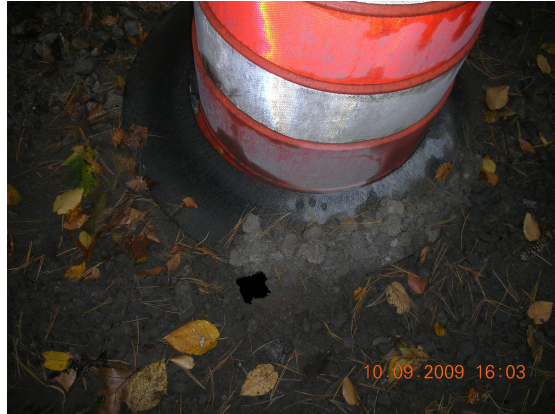
While the majority of the drainage structures within active work areas are protected, I did find a few other catch basins within disturbed watersheds that should also be protected. As grading work is scheduled to commence, it is important that all structures be protected to prevent unintended filling with loose materials. I have discussed these structures with Alan Visco, and he agreed to get liners for the catch basin located at approximately station point 25+50 on the south side of Route 62, and the catch basin located just west of Cranberry Lane, also on the south side of Route 62. The following photos show the structures :

1. The contractor should replace the catch basin liners in the drainage structure at station point 25+50 on the south side of Route 62 and within the structure to the west of Cranberry Lane (station point 23+90).

2. All catch basins should be lined with geo textile paper prior to the commencement of road grading activities.
3. The contractor should address the sedimentation that has occurred down gradient of the drainage outfall at station point 15+00. Raking and hand work is the appropriate remediation.

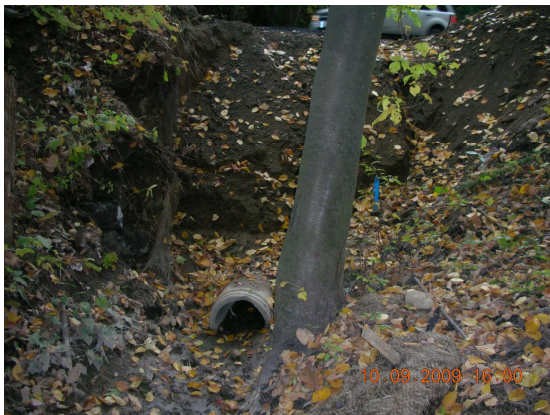
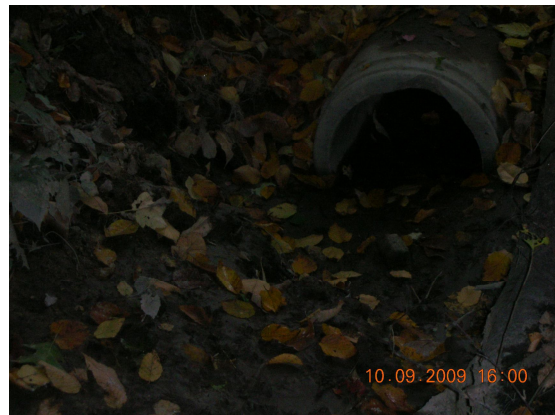
Recent activity at the shoulder of Route 62, north of the outfall located at station point 23+25 has caused instability above the outfall. While it appears that the recent work is related to the installation of a new catchbasin and manhole within the right of way, material is sliding downgradient to the drainage outfall. This is causing loose sediments to accumulate at the opening of the drainline shown below. The Contractor should complete this work, remove the excess fill and stabilize the slope below Route 62 as quickly as possible. The following photos show this area of concern:

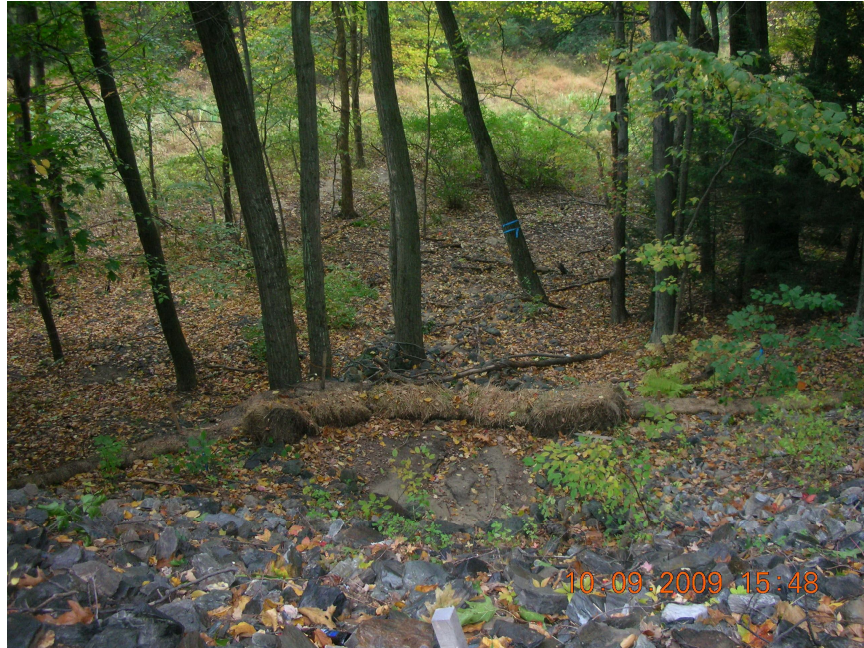
I also had some residual concern with the outfall at station point 15+00, on the north side of Route 62. While the erosion controls looked intact, it was apparent that there has been some historic discharge of sediment to downgradient buffer zone and wetland resource areas. While I suspect the discharge happened several weeks ago, the recent die back of the herbaceous plants in the locus has revealed the drainage patterns below the outfall. While the accumulations are not significant, the contractor should send a laborer to rake and remove any deposits of material. The following photo shows this area on October 9, 2009:

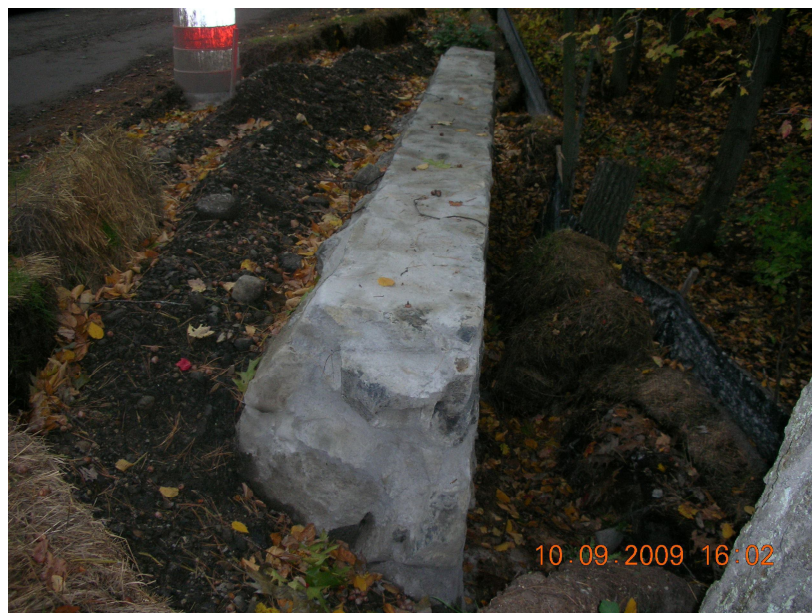
As noted in earlier reports, I am concerned with the upcoming detailing of the slope adjacent to either end of the easternmost retaining wall. This wall is located at approximately station point 27+50, on the south side of Route 62. I spoke with Alan Visco of EH Perkins Construction and noted that I am concerned that the work should include stone and hand work to stabilize the area at either end of the wall. The contractor should insure, particularly on the eastern end of the wall (left hand photo below) that the materials used to stabilize the slope utilize the erosion controls for support. The toe of the finished slope should be set, and stabilized, at the back side of the retaining wall, and should not encroach onto the down gradient silt fence barrier. The following photo shows the areas of concern, as well as the recently installed hay bales above the new wall (at the southern edge of Rt 62):

5. The contractor should consider the slope treatment of either end of the retaining wall at station point 27+00, on the southern shoulder of Route 62, and should plan on hand work in the more sensitive areas.

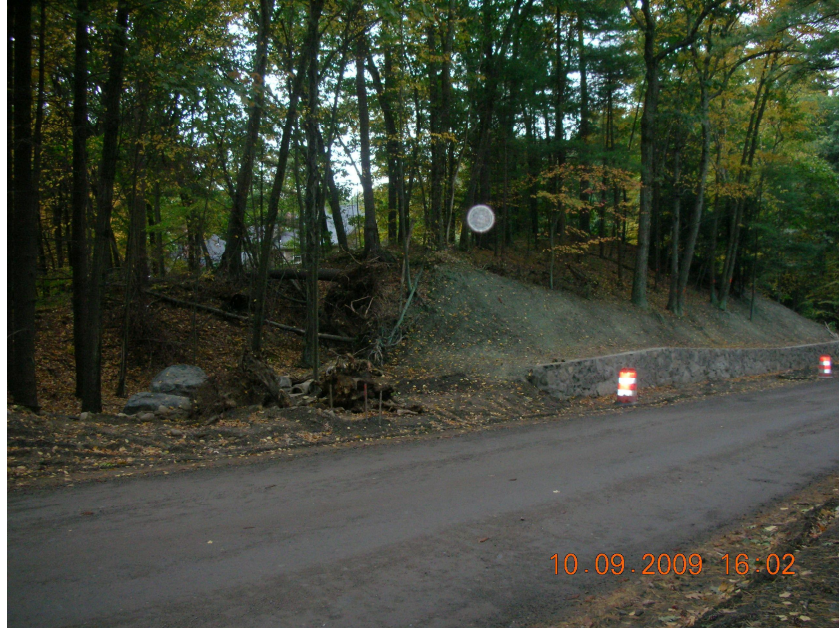
Also noted in earlier reports, Mrs. Sulewski, a condominium owner on Cranberry Lane noted that a tree fall at the south side of Route 62, at approximately station point 25+75 has fallen into and across her yard. Alan Visco and Minot Wood of EHPerkins Construction have determined that the tree fall is within forty feet of the centerline of the road (and is their responsibility) and that it will be cut and removed when the tree cutting crew returns to the site. The following photo shows the tree roots within the job locus:

6. The contractor should remove the tree fall at station point 25+75. It should be cut and removed from the site.
7. There is also a little pile of slash on the south side of the erosion controls at station point 28+25 (south side of Route 62) that should be pulled and disposed of off site. This was left by the tree cutters in the initial clearing of the site.
